104508-AC-DOGM-L001

**Re: Permit # M/049/0076 – Lake Point Quarry
Response to Minerals Inspection Report March 3, 2014**

Lake Point Quarry (M/049/0076)
Main Access Road Erosion Problem Corrections
Photo Documentation

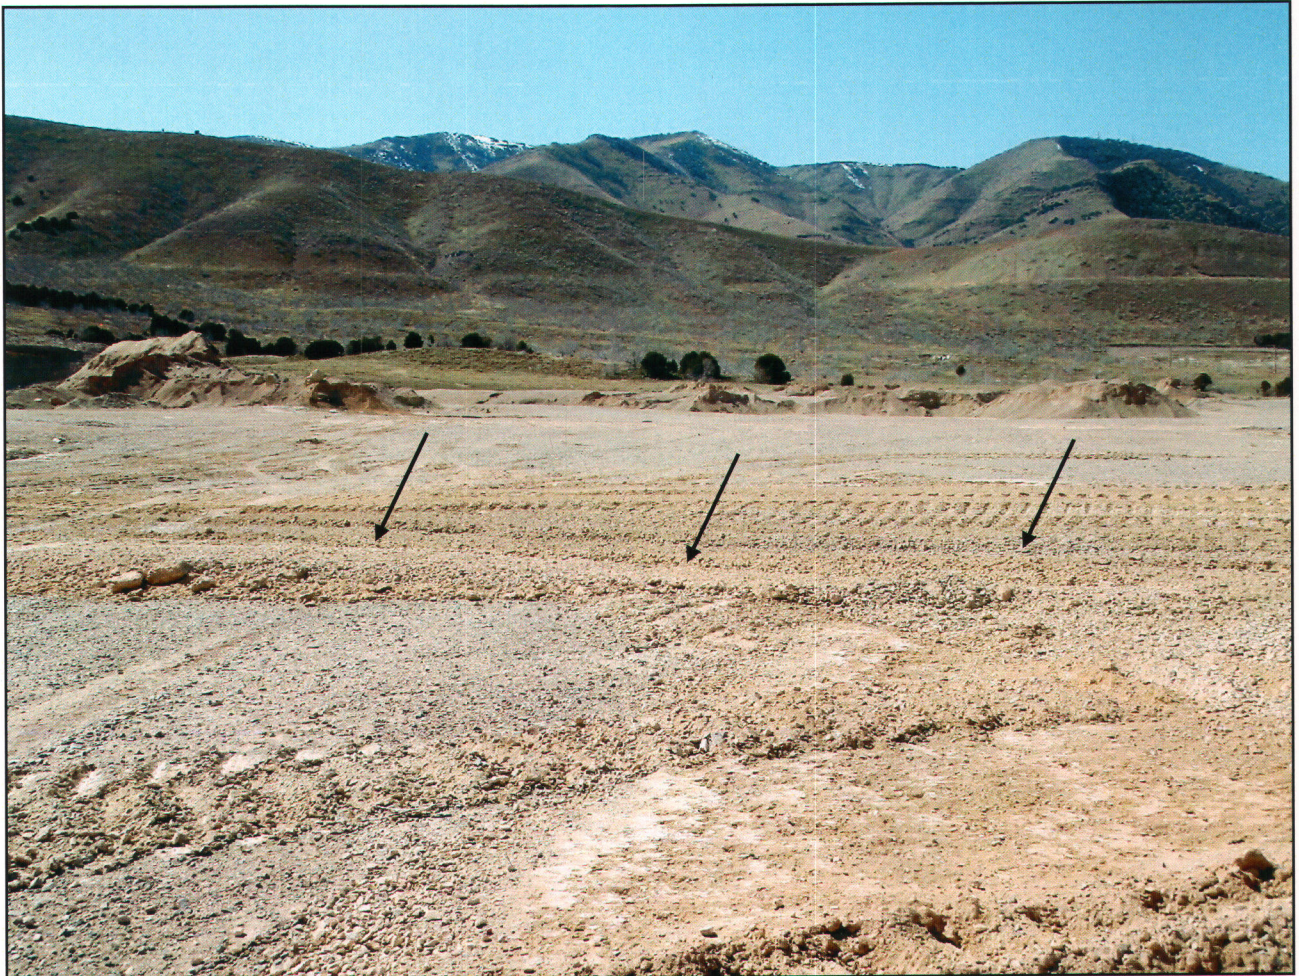
**ARROWS INDICATE DIRECTION OF FLOW - INTERCEPTOR SWALE #1 - CATCHES A MAJORITY OF
THE SITE'S UPGRADIENT RUNOFF - LOOKING WEST**

Within a couple weeks of this site visit, Ames addressed the main access road erosion issues discovered during the routine inspection. Ames constructed three interceptor swales (inverse water bars) to carry stormwater from the main access road to adjacent self-contained areas. Please refer to the enclosed photo documentation.

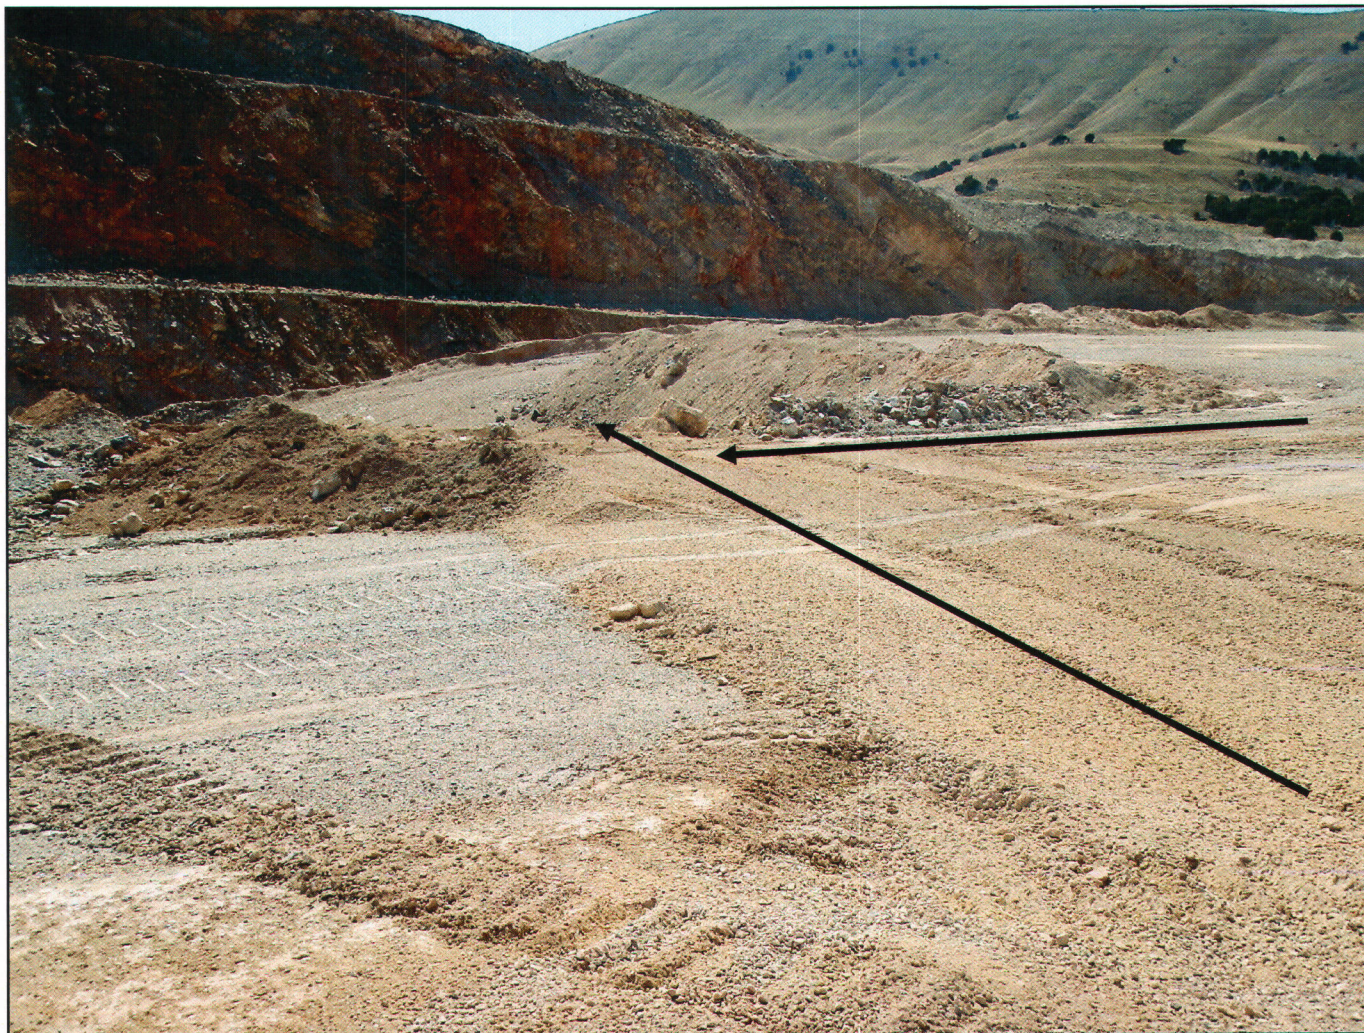
ARROWS INDICATE DIRECTION OF FLOW -INTERCEPTOR SWALE #1 - AMES ALLOWED WATER TO
DISCHARGE INTO THE PIT FOR INFILTRATION THEREBY ALLEVIATING FLOW DOWN THE MAIN
ACCESS ROAD - LOOKING SOUTHWEST

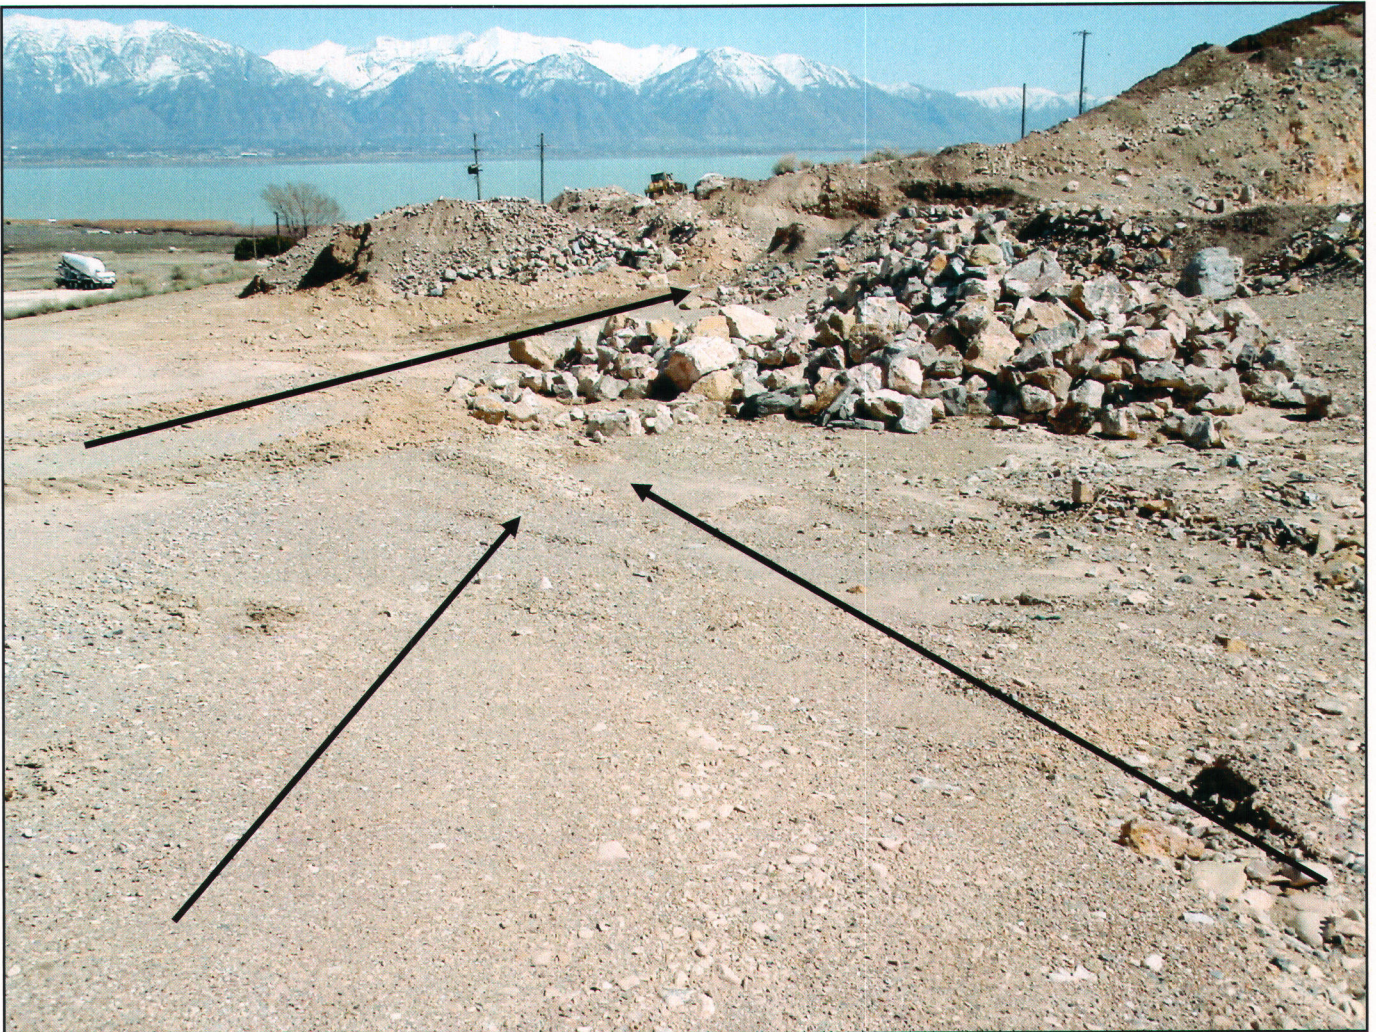
ARROWS INDICATE DIRECTION OF FLOW -INTERCEPTOR SWALE #2 - AMES ALLOWED WATER TO
DISCHARGE INTO THE PIT FOR INFILTRATION THEREBY ALLEVIATING FLOW DOWN THE MAIN
ACCESS ROAD - LOOKING SOUTHEAST

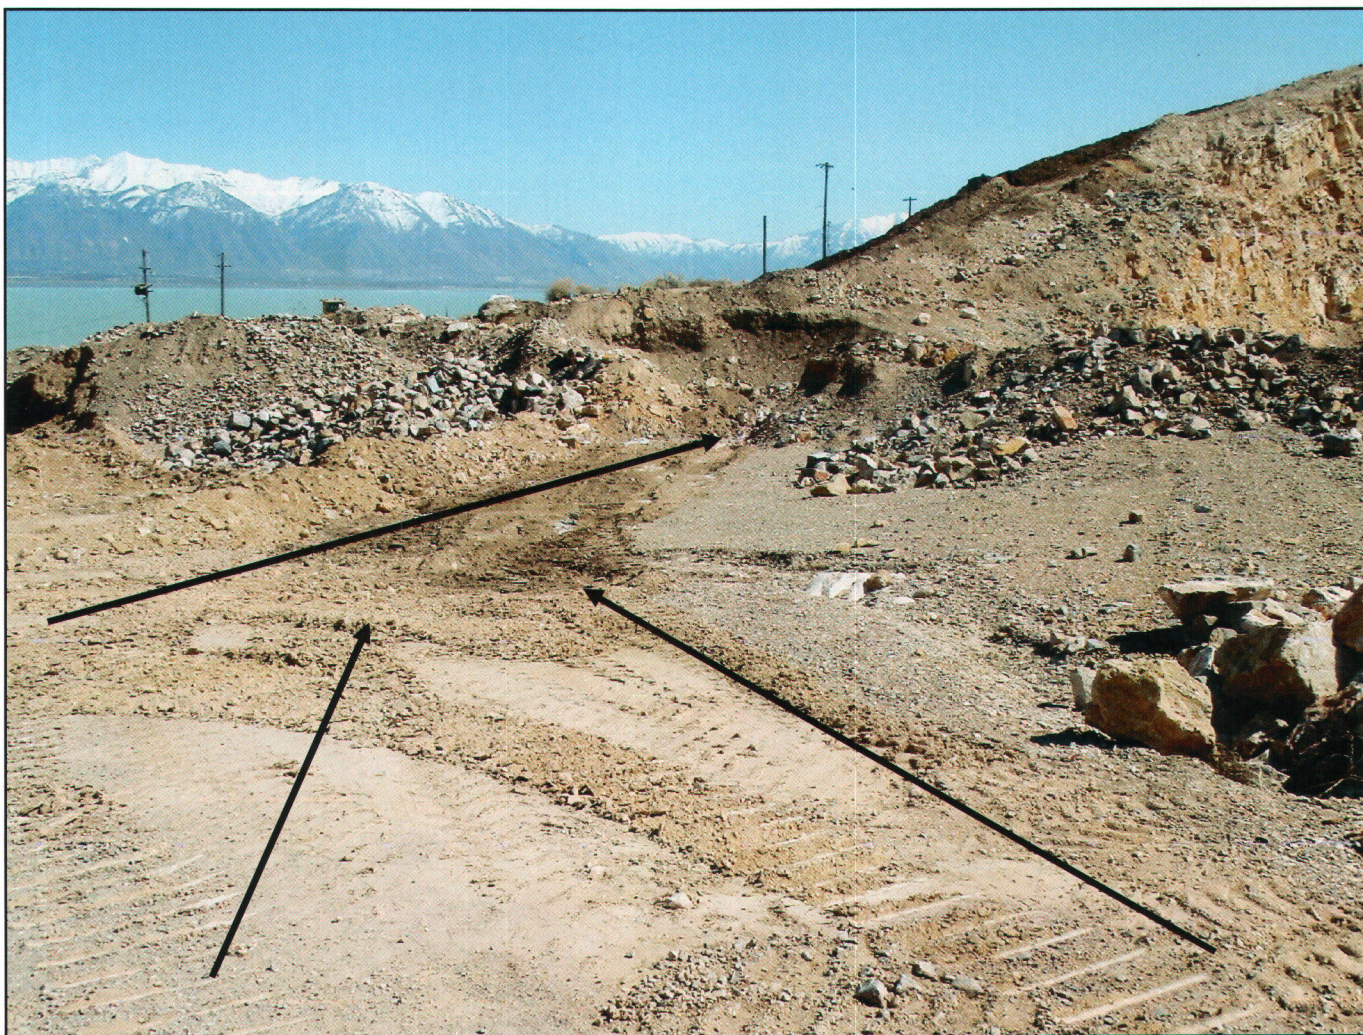
ARROWS INDICATE DIRECTION OF FLOW -INTERCEPTOR SWALE #2 - AMES ALLOWED WATER TO DISCHARGE INTO THE PIT FOR INFILTRATION THEREBY ALLEVIATING FLOW DOWN THE MAIN ACCESS ROAD - LOOKING SOUTHEAST

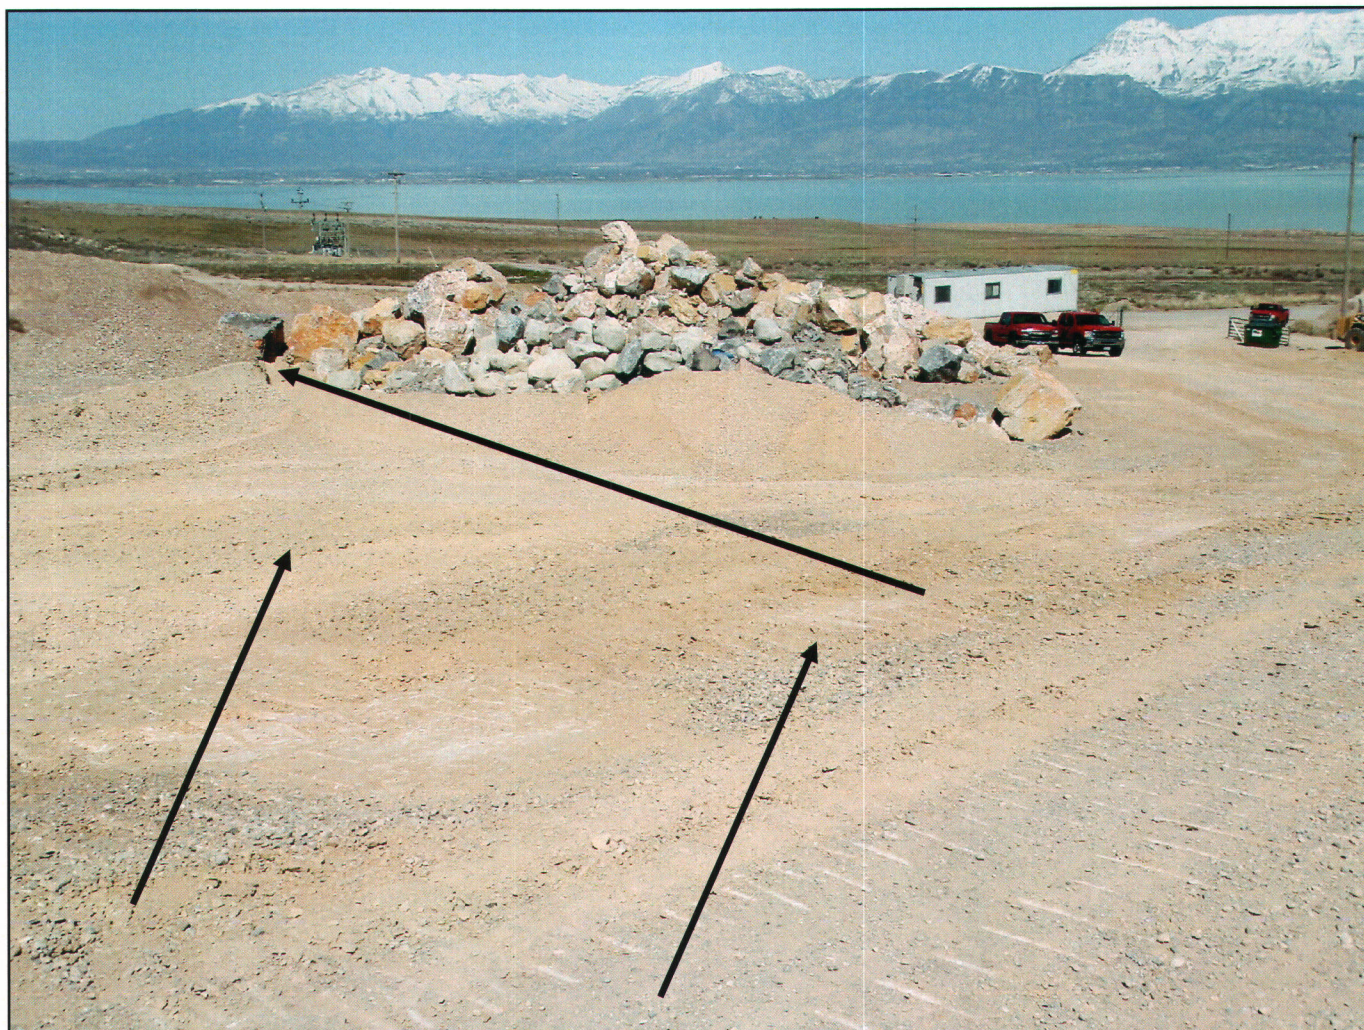
ARROWS INDICATE DIRECTION OF FLOW -INTERCEPTOR SWALE #3 - AMES ALLOWED WATER TO
DISCHARGE INTO A STOCKPILE AREA FOR INFILTRATION THEREBY ALLEVIATING FLOW DOWN
THE MAIN ACCESS ROAD - LOOKING NORTHEAST

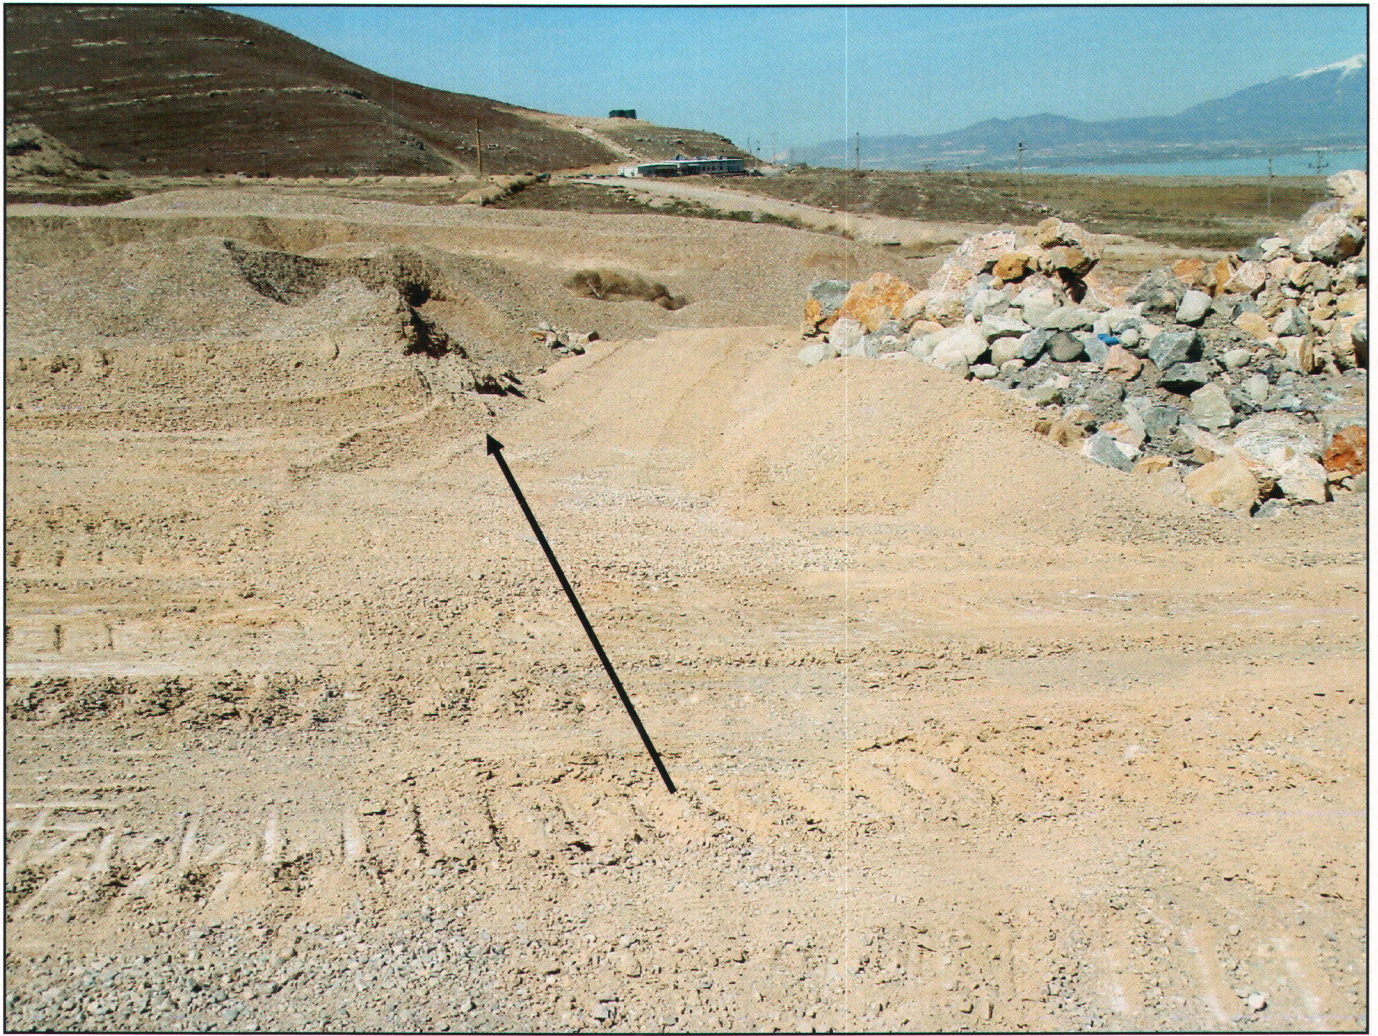
ARROWS INDICATE DIRECTION OF FLOW -INTERCEPTOR SWALE #3 - AMES ALLOWED WATER TO
DISCHARGE INTO A STOCKPILE AREA FOR INFILTRATION THEREBY ALLEVIATING FLOW DOWN
THE MAIN ACCESS ROAD - LOOKING NORTH

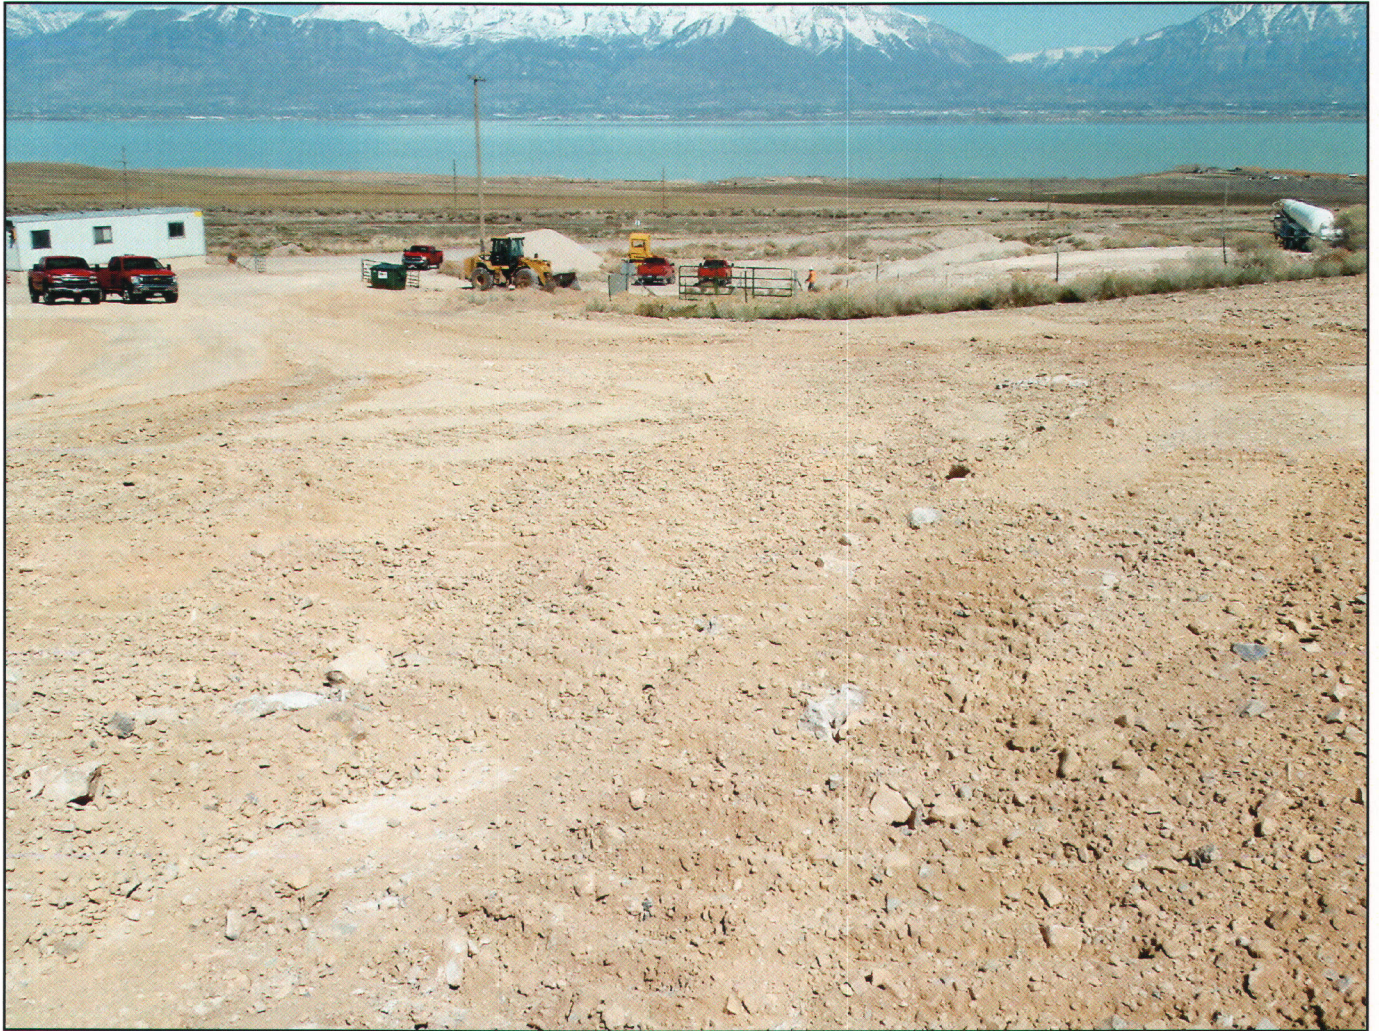
AMES REGRADED THE ACCESS ROAD TO ALLEVIATE EROSION RILLS AND GULLIES - THIS WAS COMBINED WITH INSTALLING THE UPGRADIENT SOURCE CONTROL (INTERCEPTOR SWALES) TO RECTIFY THE ISSUE
